**CONSENT ORDER
ISSUED UNDER THE
WATER POLLUTION CONTROL ACT
WEST VIRGINIA CODE, CHAPTER 22, ARTICLE 11**

TO: MarkWest Liberty Midstream & Resources, L.L.C. DATE: March 28, 2019
Gregory Bezdek, SVP, NE Region
4600 J Barry Ct. Ste 500
Canonsburg, PA 15317 ORDER NO.: 8945

MARKWEST LIBERTY MIDSTREAM & RESOURCES, L.L.C, WVR311004, Sherwood to Mobley
20" NGL, 8/22 & 8/23/2018

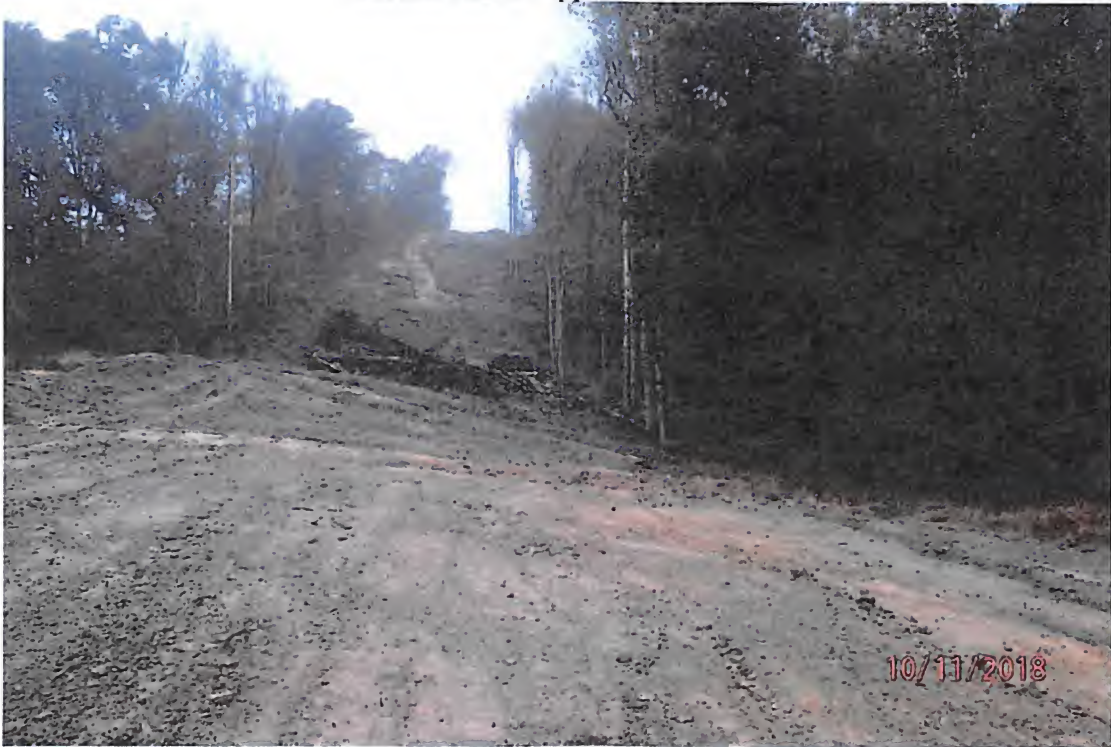
Area of disturbance from 561+00 to 588+00 that lacks water bar terminus BMPs and perimeter controls indicated in the approved SWPPP.

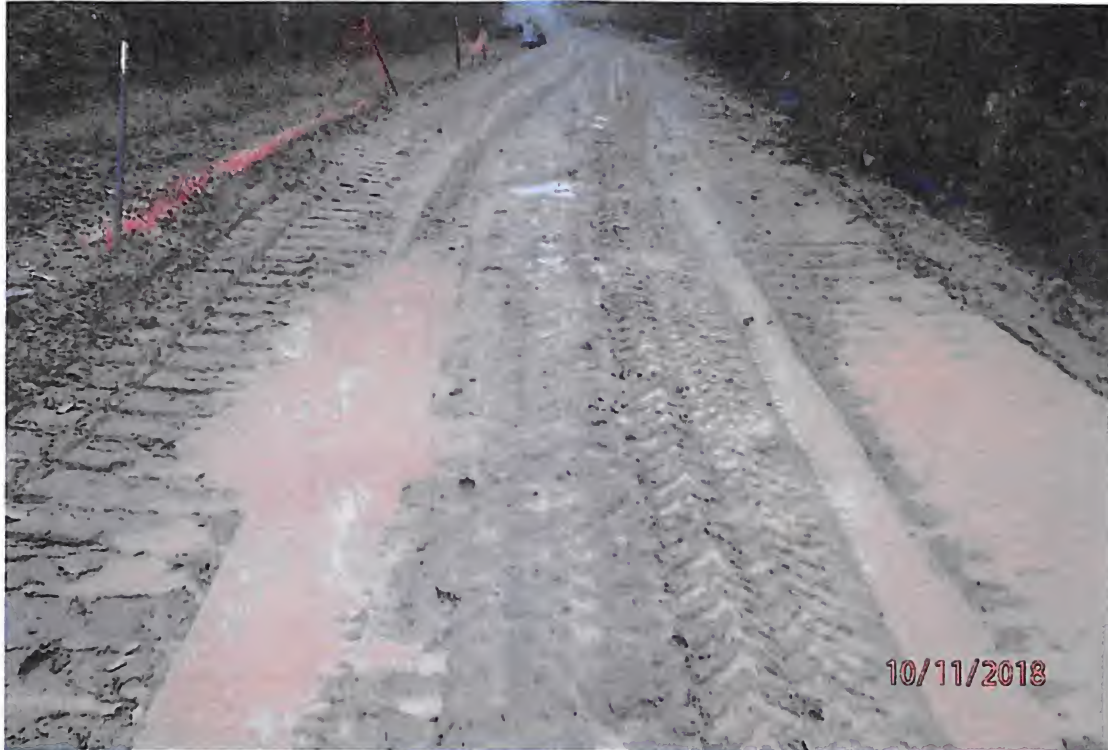
Area of disturbance from 561+00 to 588+00 that lacks water bar terminus BMPs and perimeter controls indicated in the approved SWPPP.

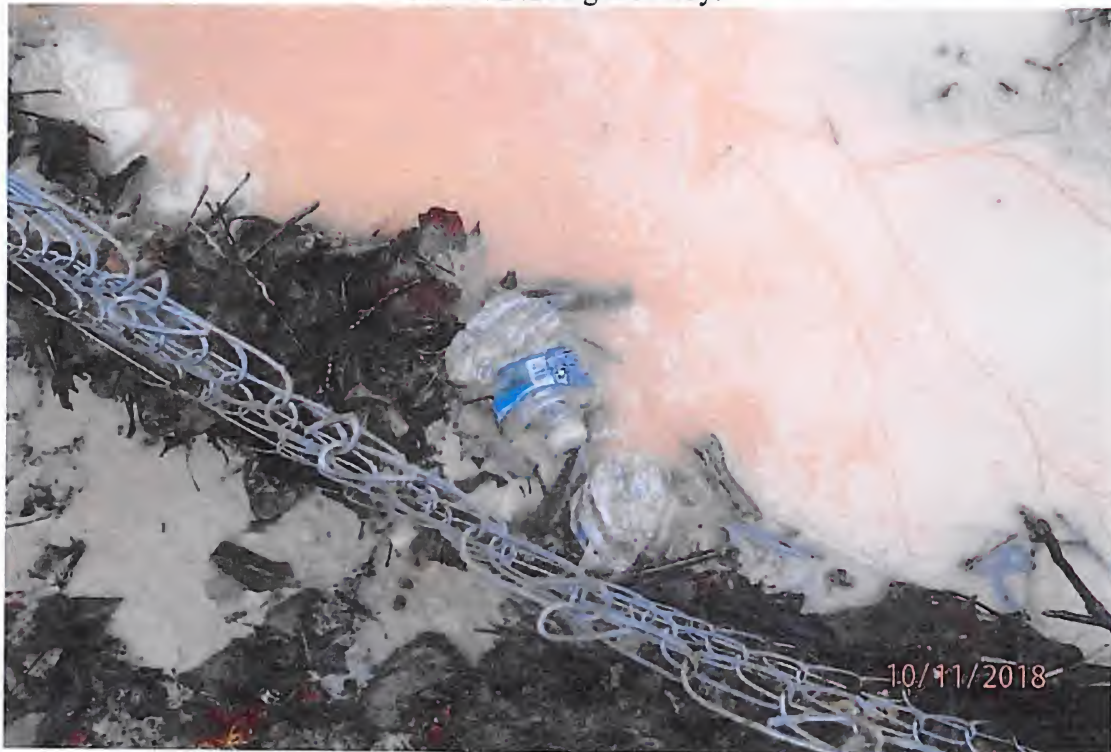
Trash on the right of way.

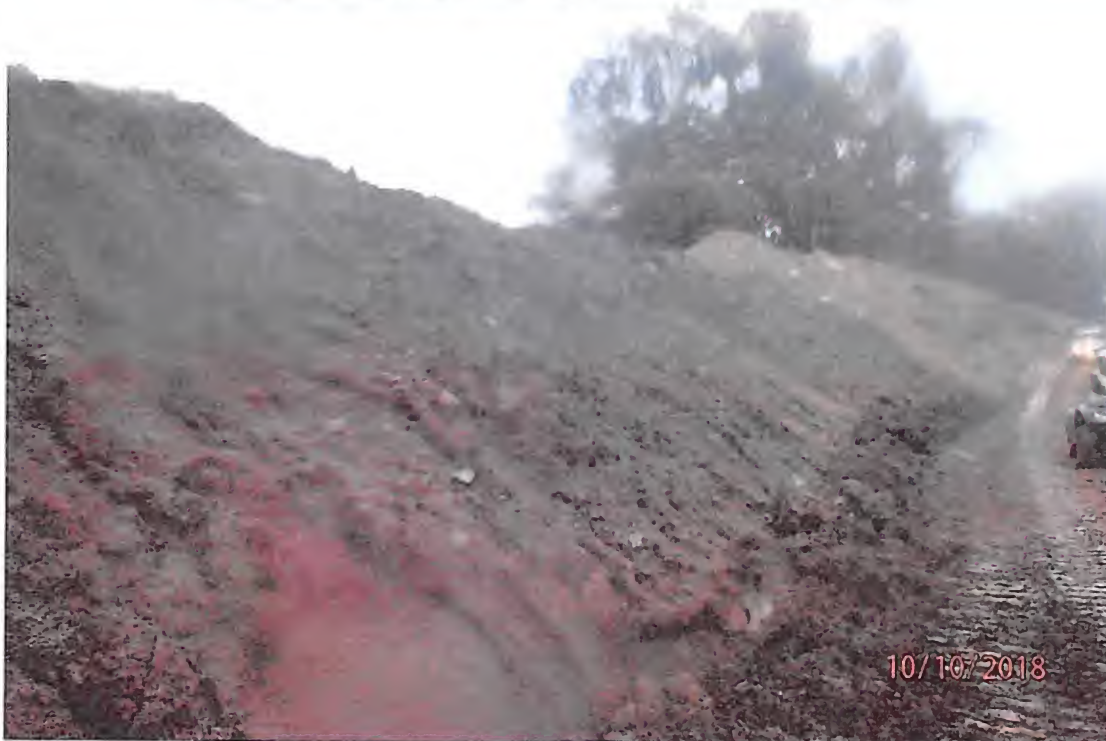
Stockpile that lacks temporary stabilization near 287+00.

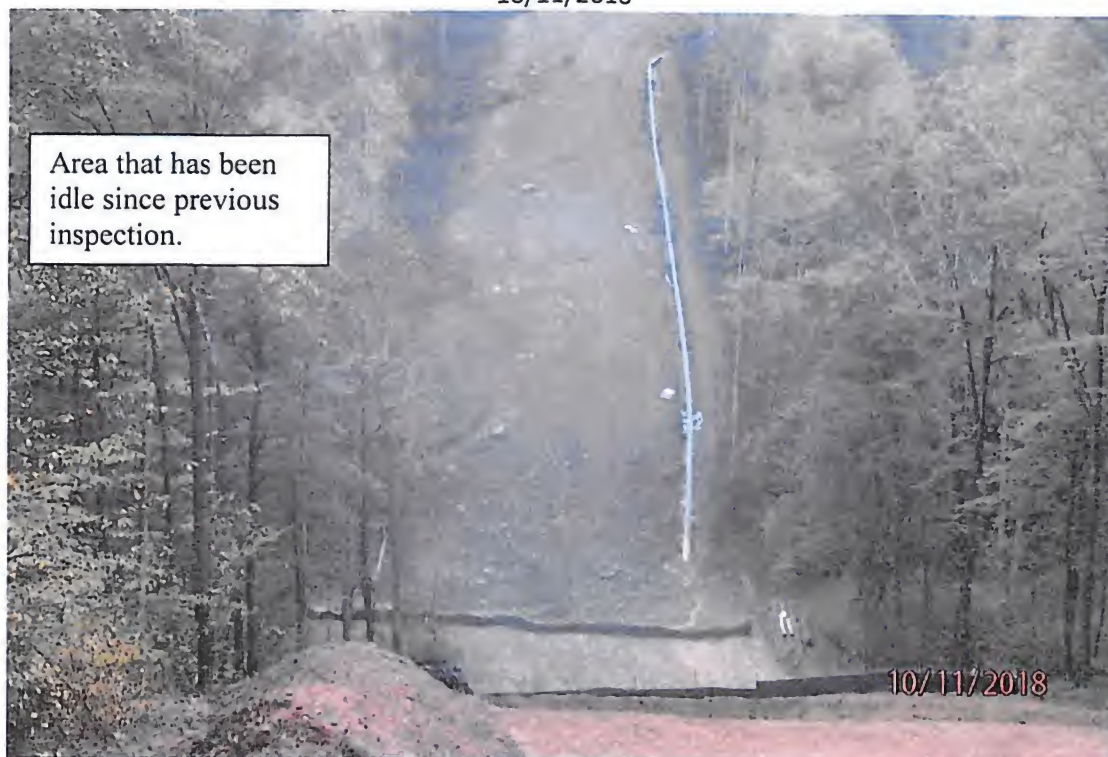
Stockpile that lacks temporary stabilization near 350+80.

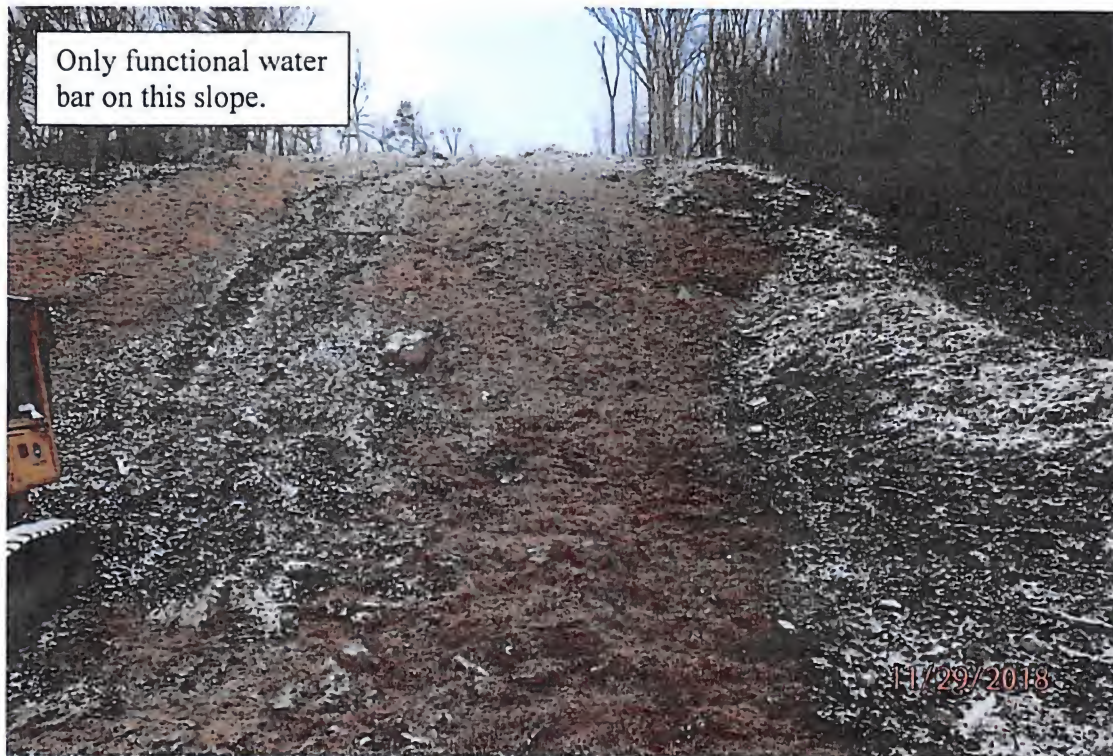
Right of way that lacks temporary stabilization near 862+00.

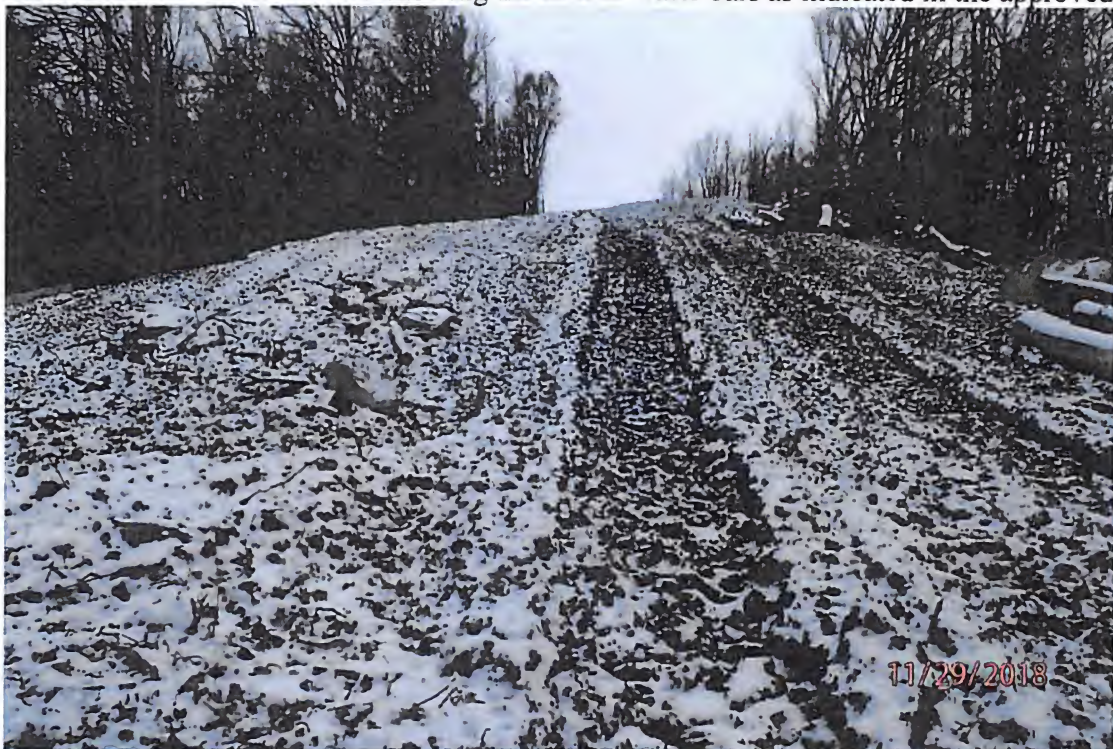
Inspected area from 661+00 to 669+00 showing the lack of water bars as indicated in the approved SWPPP.

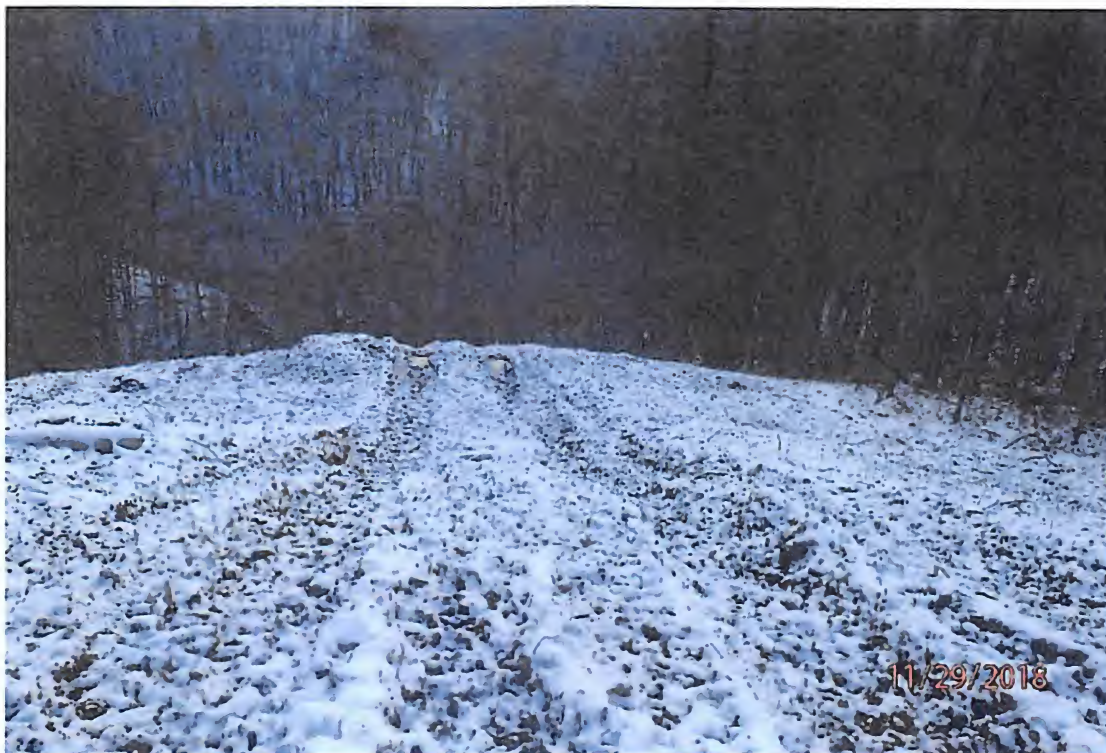
Inspected area from 675+00 to 682+00 showing the lack of water bars as indicated in the approved SWPPP.

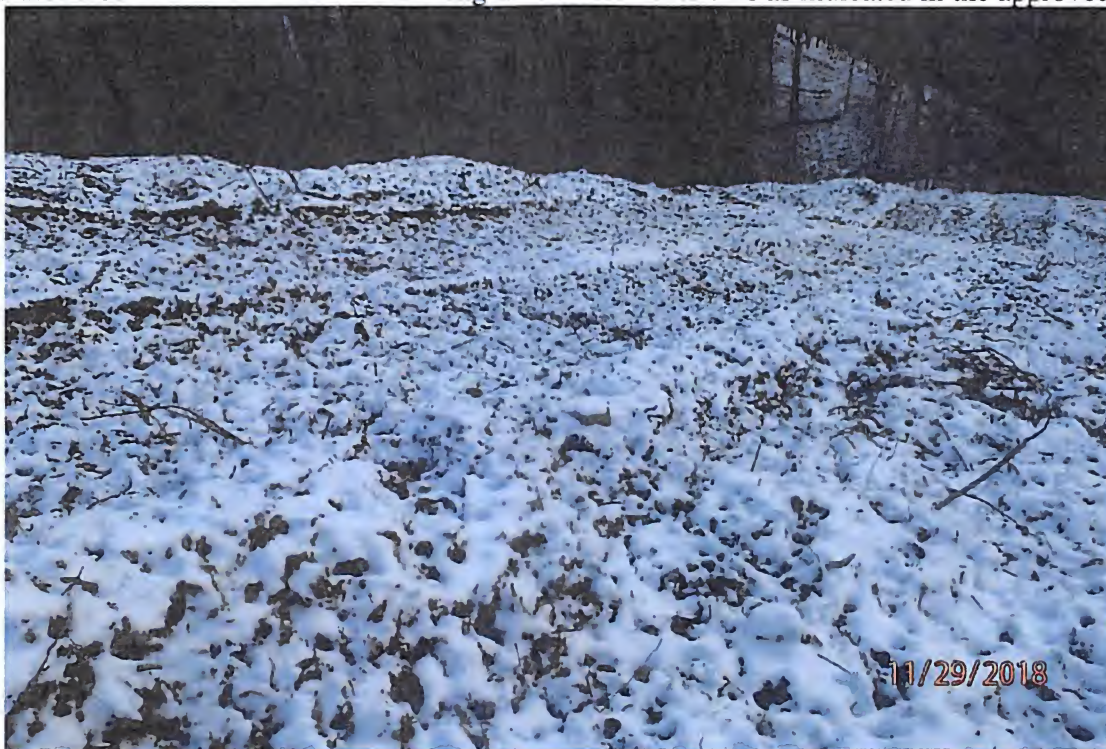
Inspected area from 675+00 to 682+00 showing the lack of water bars as indicated in the approved SWPPP.

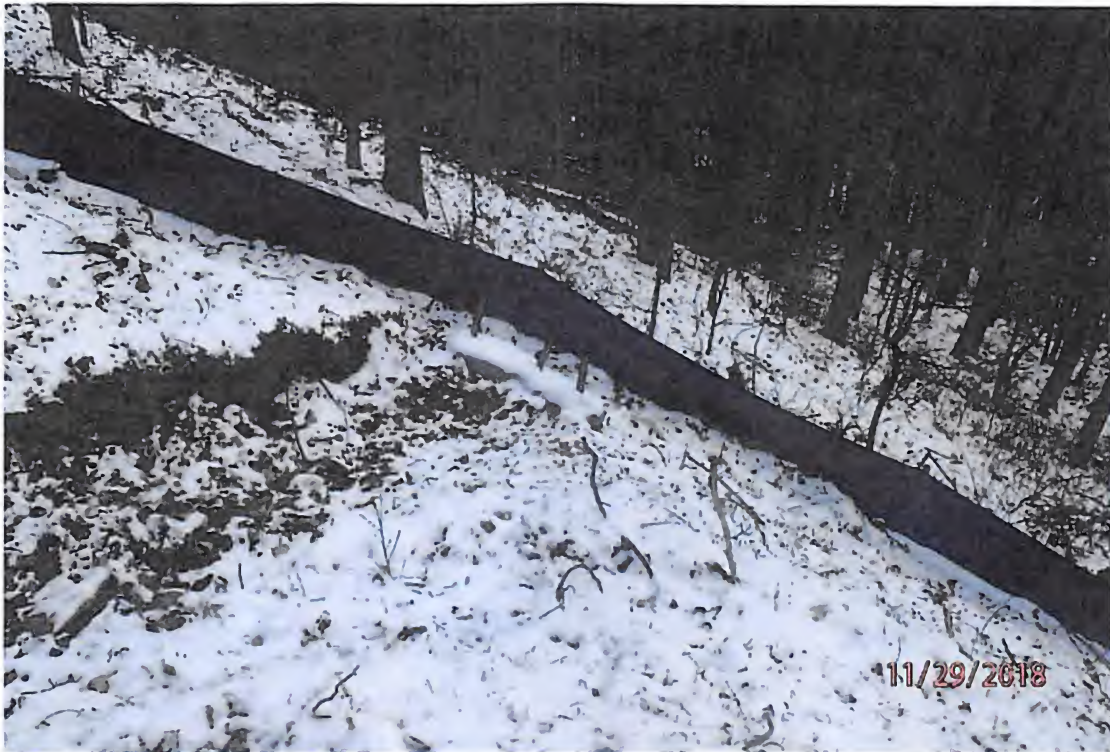
Water bar outlet that does not extend past the installed perimeter controls in the Franks Run watershed.

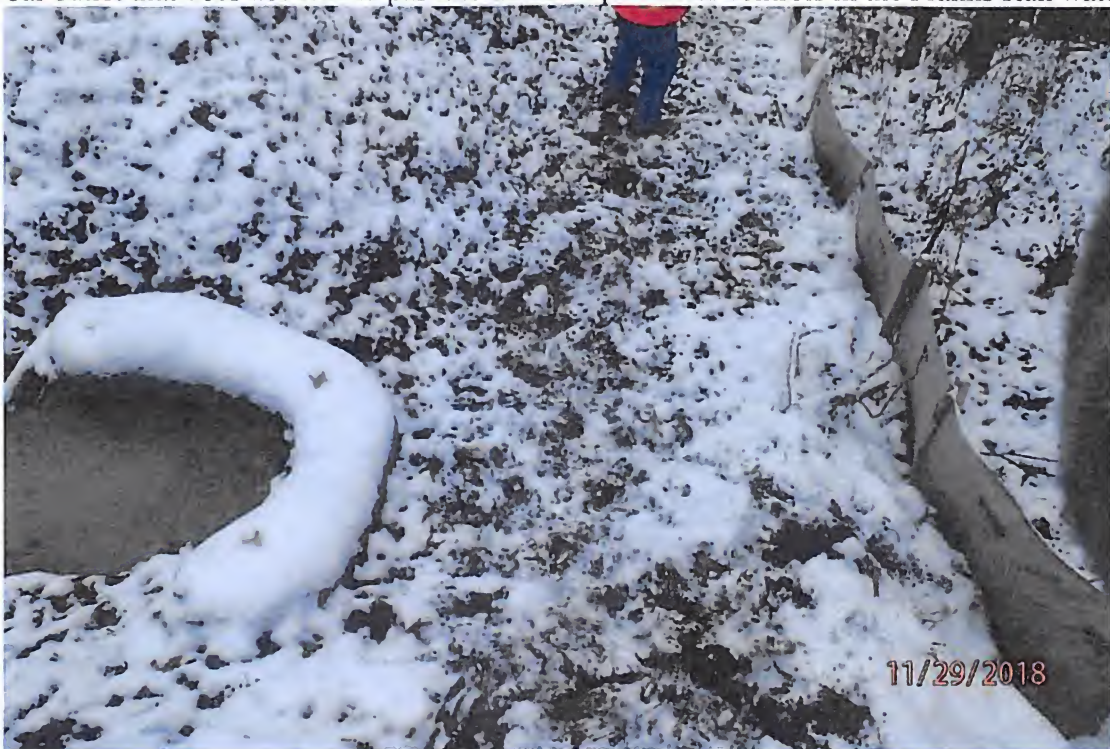
Water bar outlet that does not extend past the installed perimeter controls in the Beverlin Fork watershed.

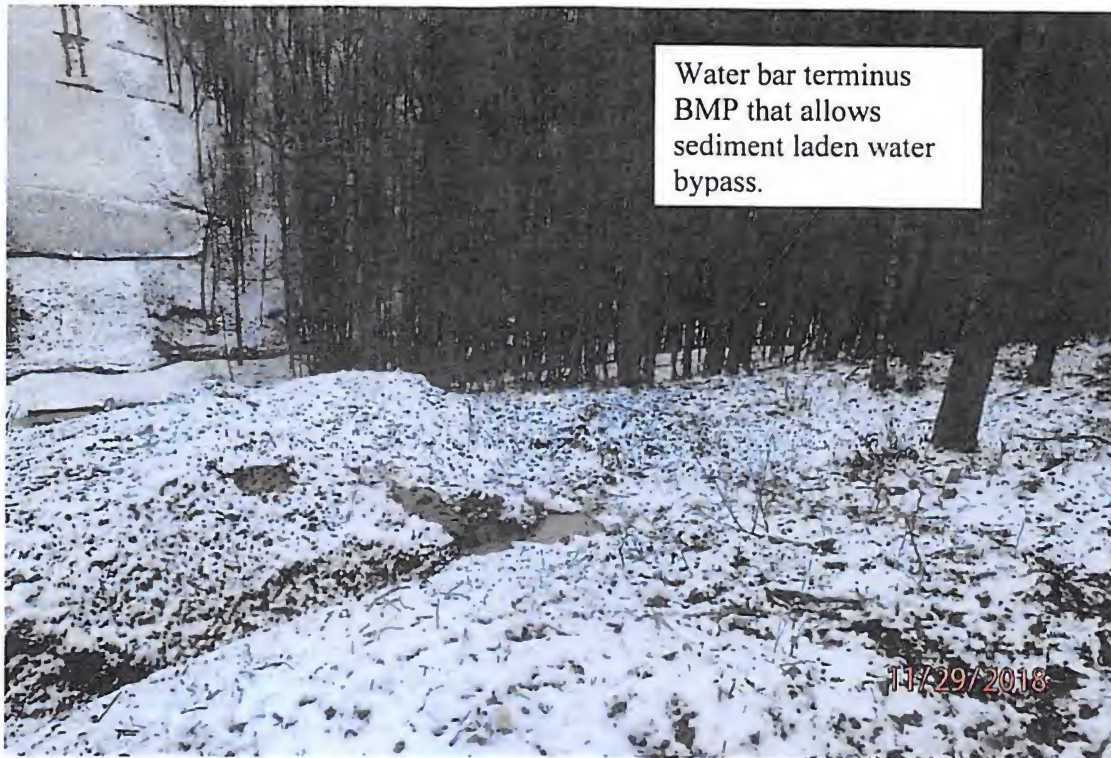
Water bar terminus BMP that allows sediment laden water bypass near 861+00.

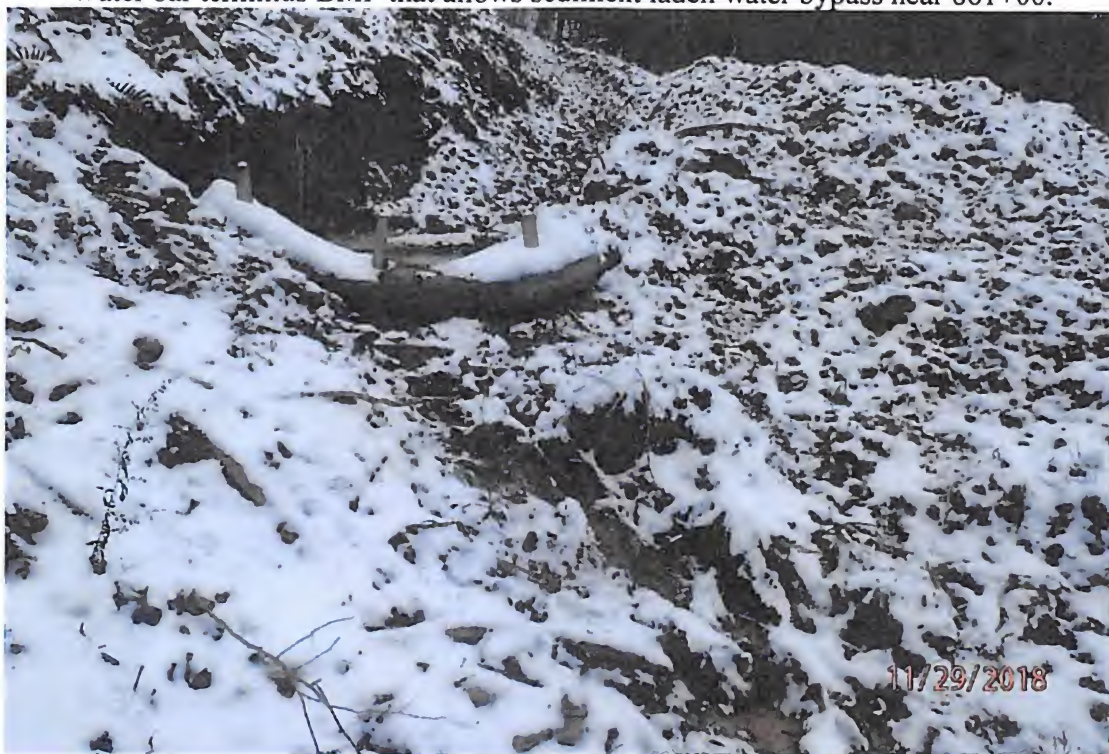
Water bar terminus BMP that allows sediment laden water bypass near 861+00.

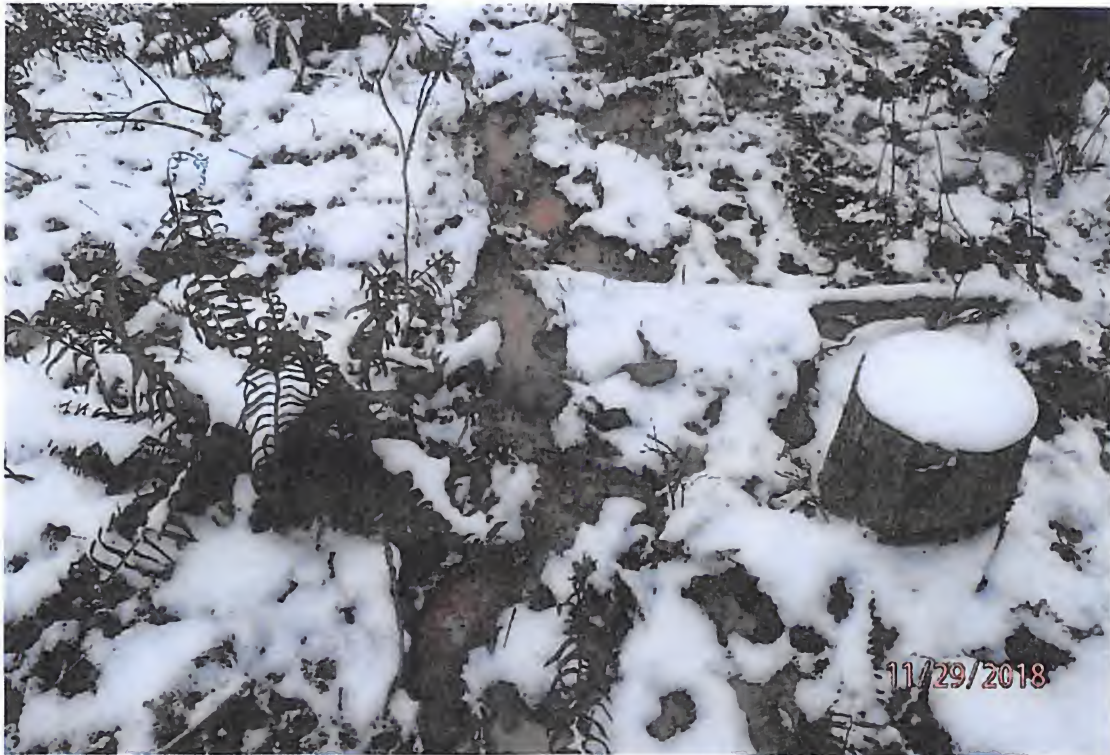
Offsite sediment laden water near 861+00 that originates from site due to a bypass at a water bar terminus BMP.

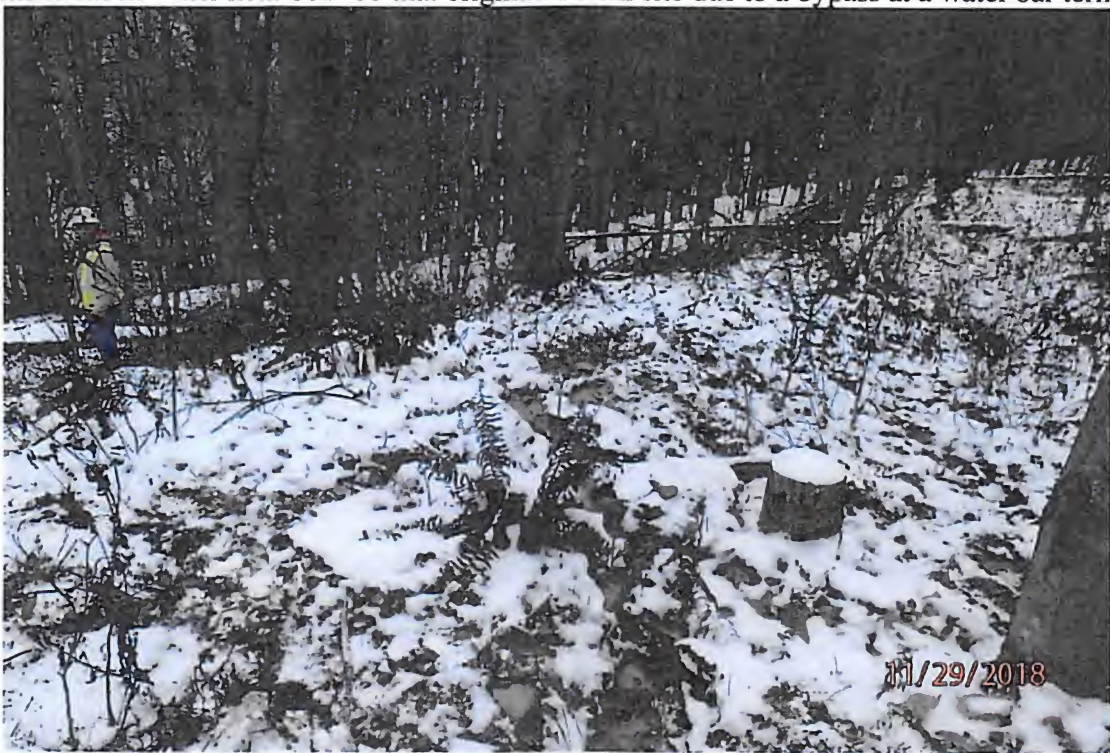
Offsite sediment laden water near 861+00 that originates from site due to a bypass at a water bar terminus BMP.

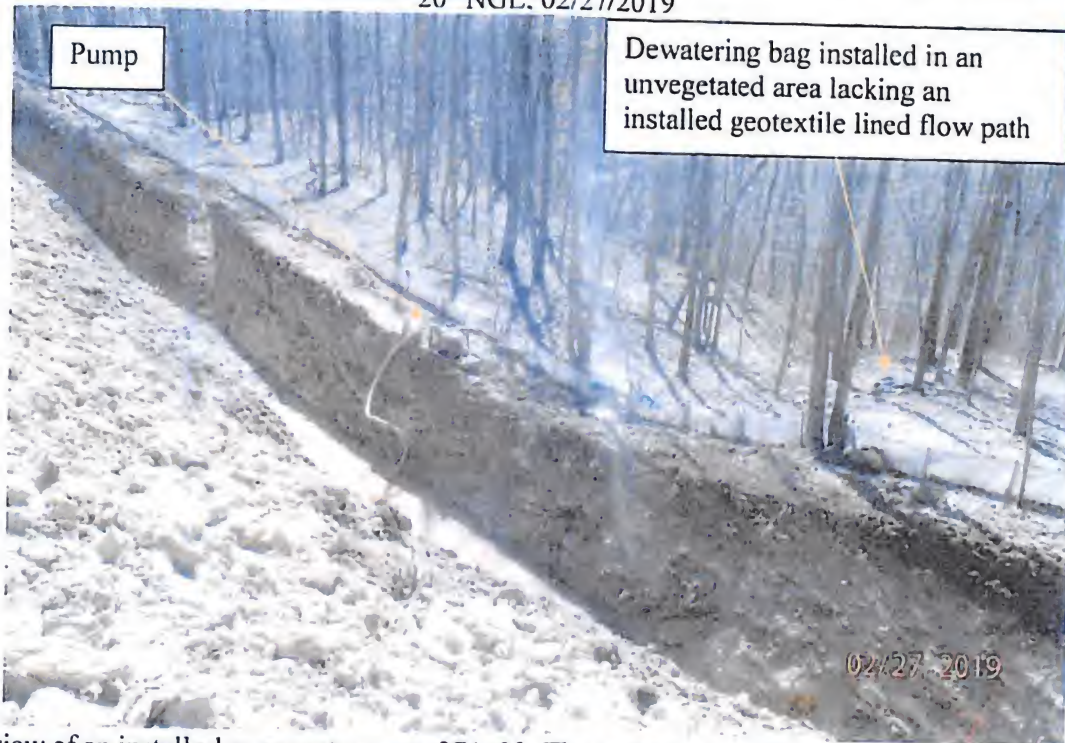
Overview of an installed pump set up near 374+00. The pump was not in use at the time of inspection.

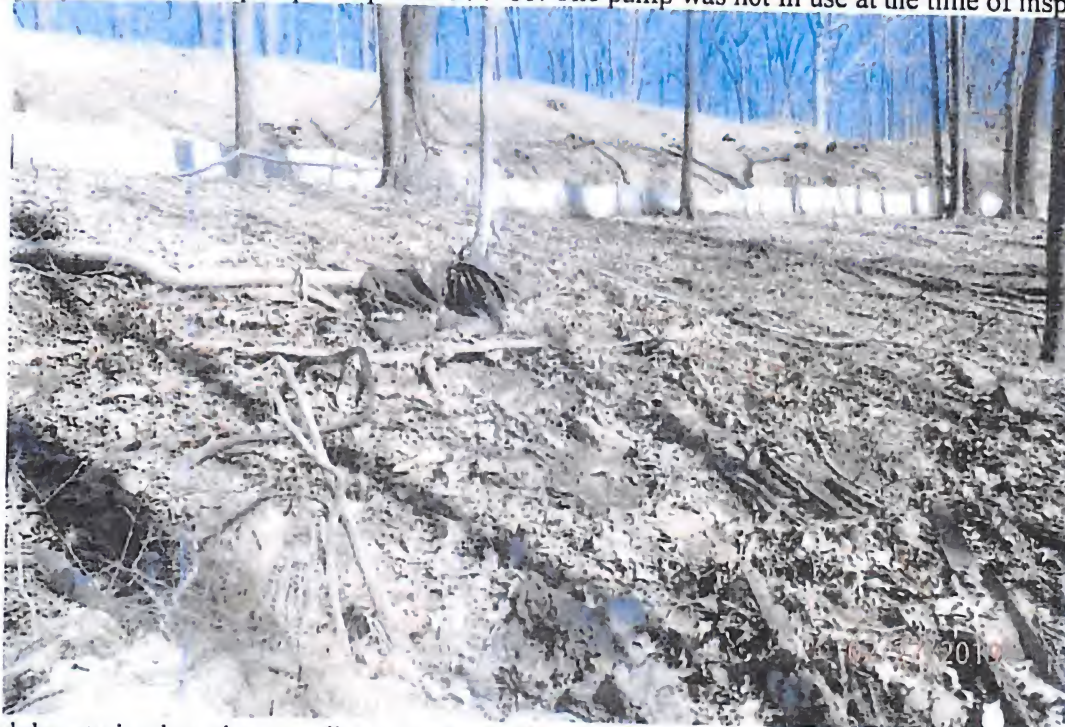
Installed dewatering bag that contributed to the visible plume in UNT Boggs Run showing the lack of an installed geotextile lined flow path and the associated erosion downslope of the device.

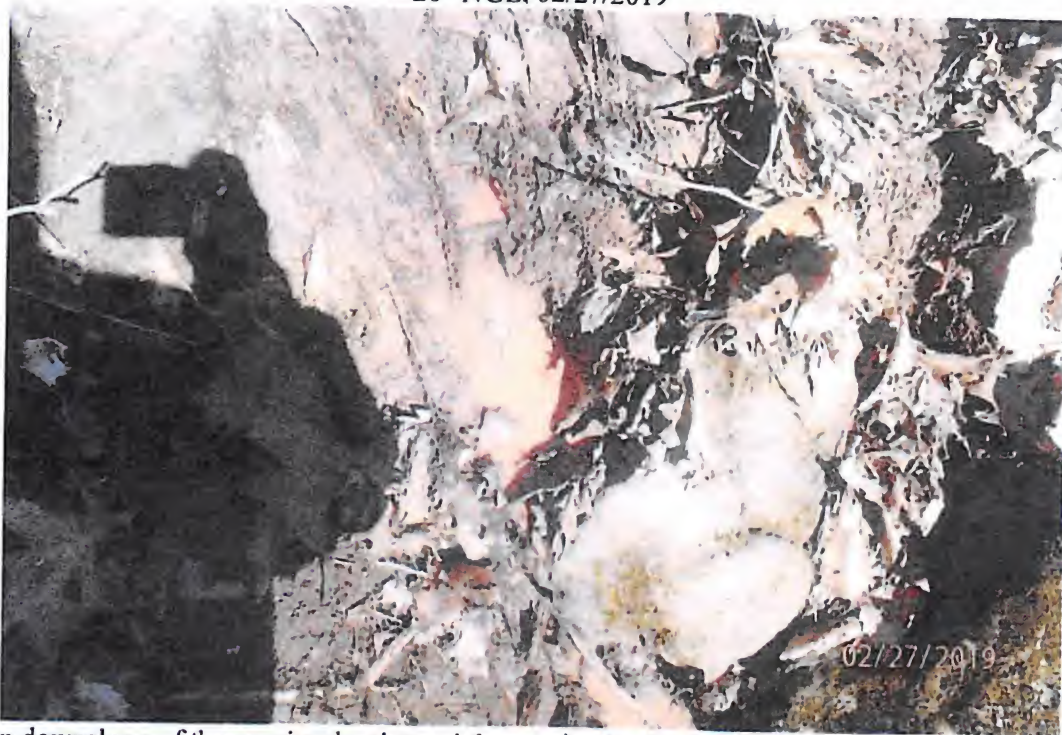
Erosion downslope of the previously pictured dewatering bag in the Boggs Run watershed showing the lack of an installed geotextile lined flow path and the associated erosion downslope of the device.

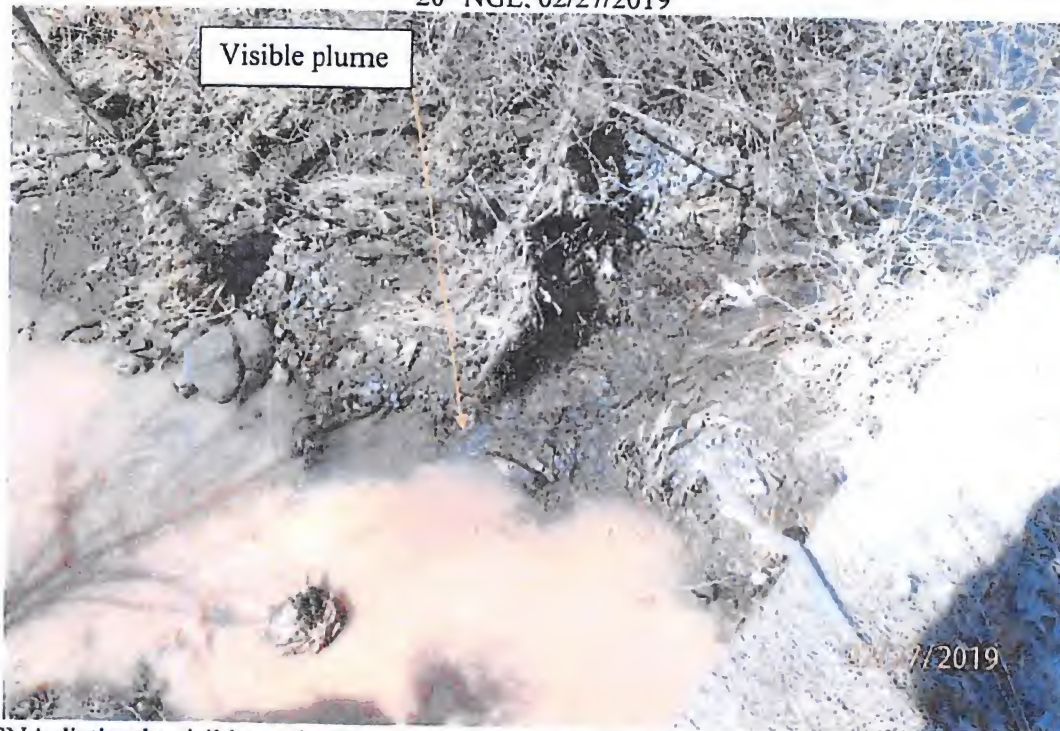
CNA distinctly visible settleable solids in Boggs Run as a result of the dewatering operation.

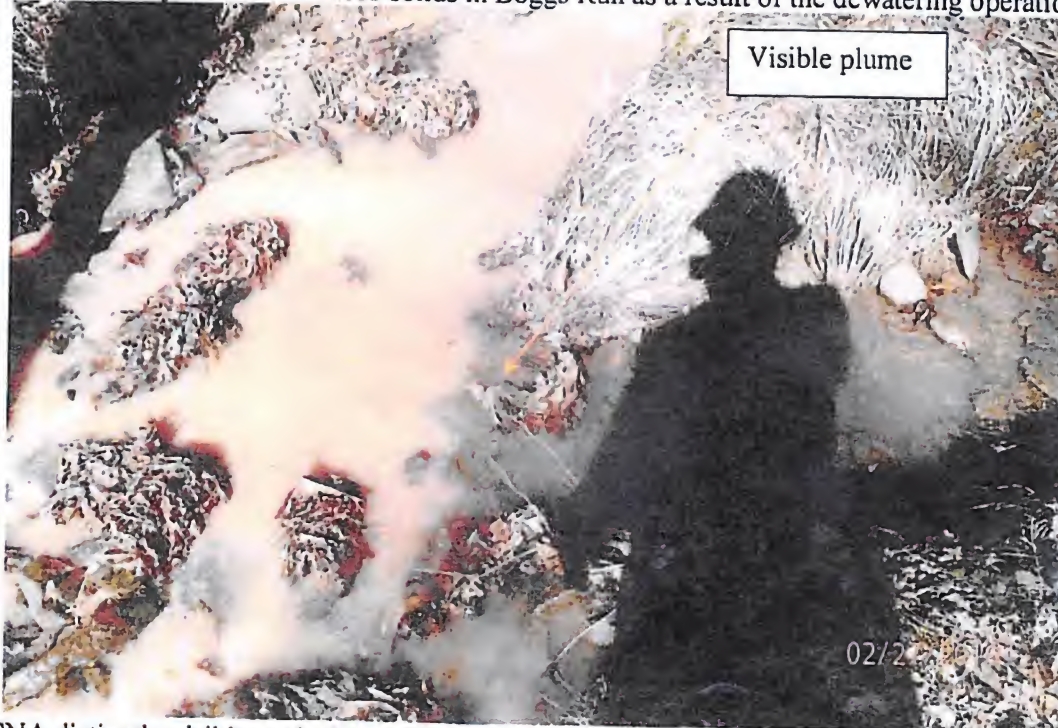
CNA distinctly visible settleable solids in Boggs Run as a result of the dewatering operation.

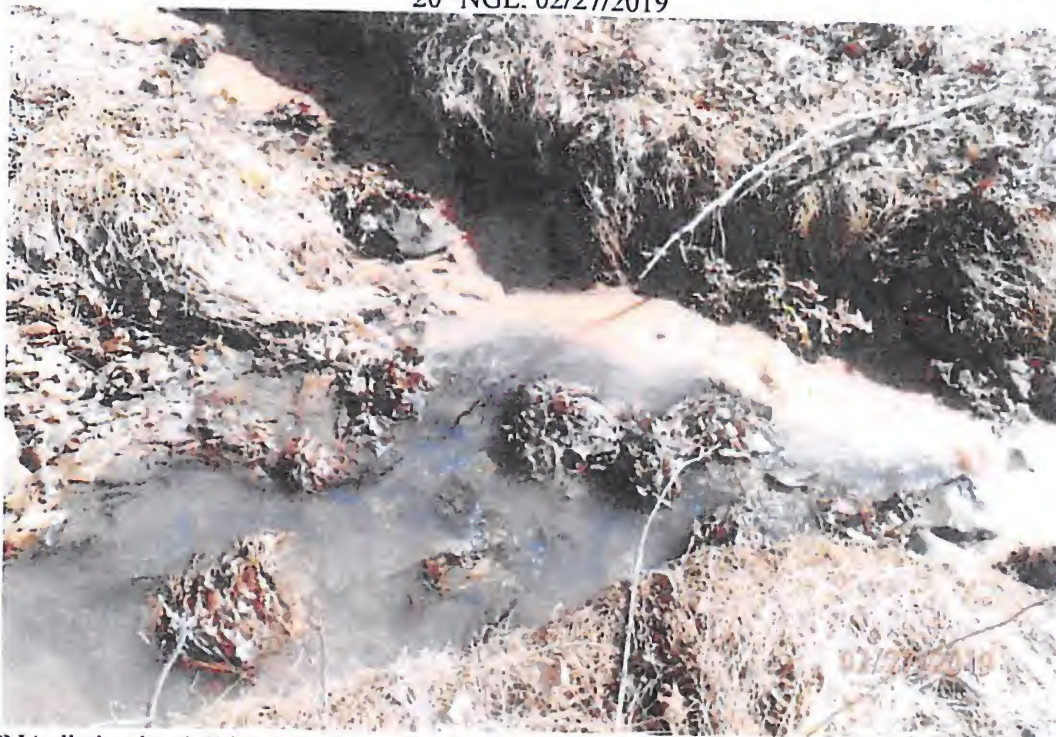
CNA distinctly visible settleable solids in Boggs Run as a result of the dewatering operation.

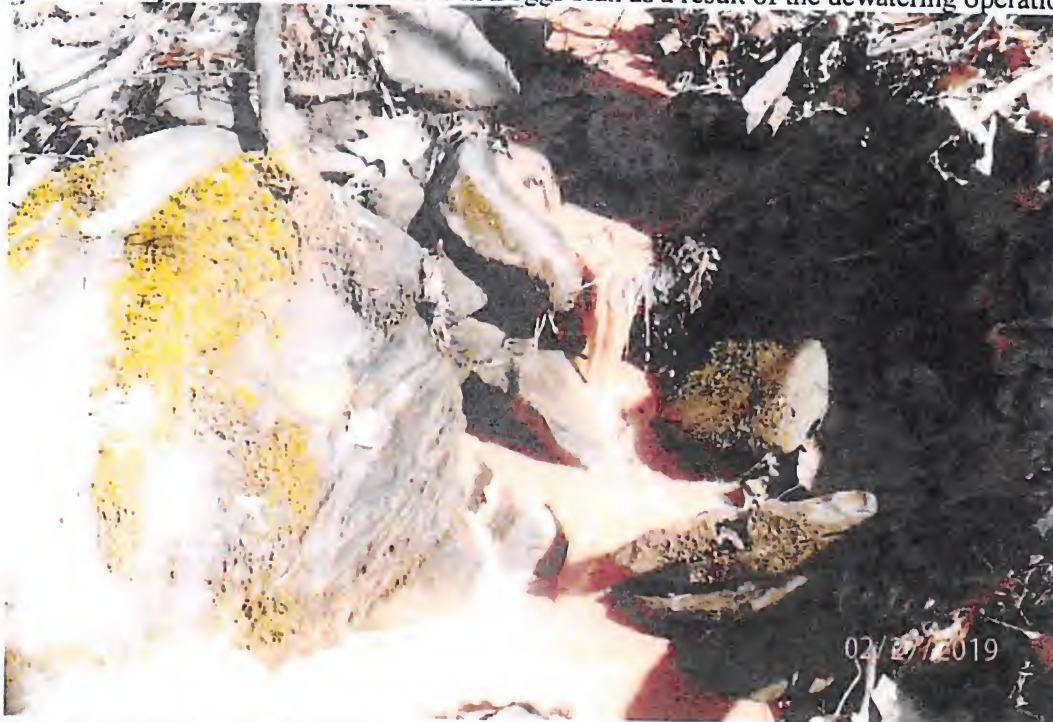
CNA distinctly visible settleable solids in UNT Boggs Run (UNT - 95) ($39^{\circ} 21.161'$ X $80^{\circ} 39.549'$) as a result of the dewatering operation.
